Parts Guide – For video instructions visit the Stella page on the Tristel website

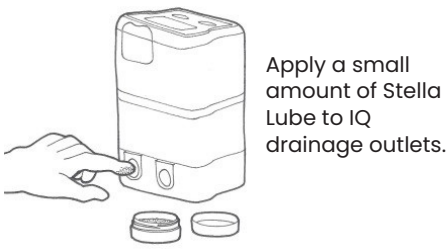
STELLA IQ LUBE

Every six months, apply a small amount of Stella Lube to Stella IQ drainage inlets.

See the parts guide section for reference on the lube process.
