Novel remediation of a decommissioned endoscope washer disinfector utilising chlorine dioxide (ClO₂) chemical dosing at the North West Cancer Centre – Tamworth, NSW

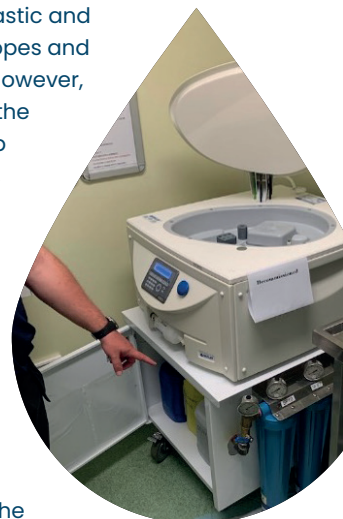
Five water samples were collected from the washer bay –before, during, and after connecting the Rinse Assure System, for independent NATA Accredited laboratory testing to confirm the original presence of microorganism contamination, and to test water quality post ClO₂ treatment process.

The water samples collected at different times throughout this process showed significant changes and appeared discoloured and visibly contaminated.

After only 8 ½ hours of ClO₂ chemical dosing, the Tristel Rinse Assure Series 3 system had reduced TVCs from >100 CFU/100ml to <1 CFU/100mL. Endotoxins were reduced significantly from concerning levels of 21.5 EU/mL to 1.6 EU/mL, and water purity was vastly improved. Below is a summary of test results.

“The Rinse Assure system was set up very quickly by Steve the Tristel Service Manager. It was only the size of a small fridge on wheels, and he simply wheeled it into our washer room and connected it up between the water outlet and the Soluscope™ washer.

He had it set up to go all in just an afternoon and once it was connected, he left it to run overnight. Steve came back in the morning to run his final system tests; collect the final water sample and then he was done.
